# CRUISE REPORT

## *R/V Kilo Moana*

### U.S. Law of the Sea Cruise to Map the Western Flank of the Kingman Reef-Palmyra Atoll Section of the Line Islands, Equatorial Pacific Ocean

Cruise KM15-20  
November 20 – December 20, 2015  
Honolulu, HI to Honolulu, HI

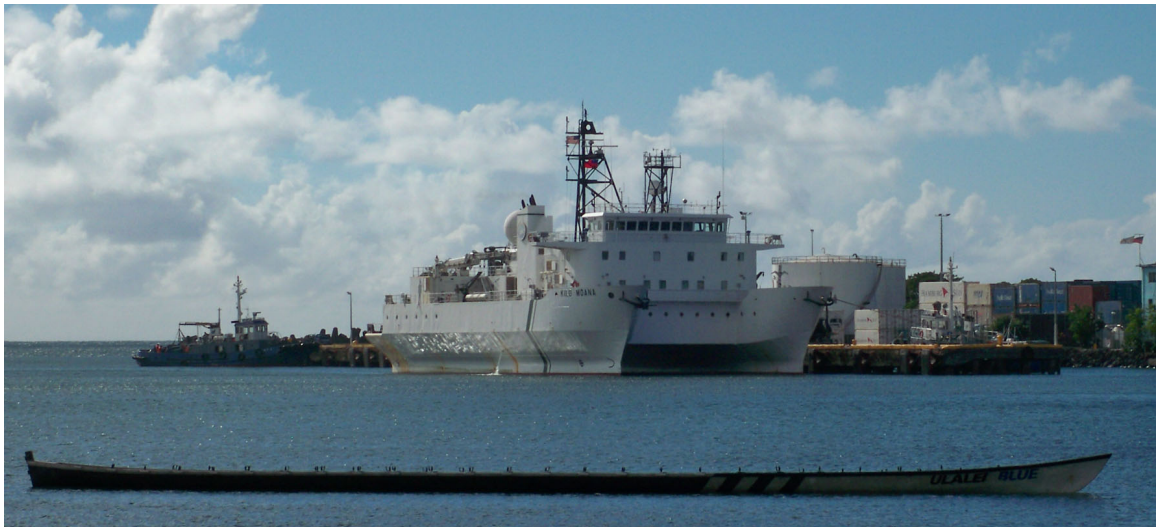
Figure 1.2: The R/V *Kilo Moana* in Apia, Western Samoa, in 2010. The *Kilo Moana* is a SWATH (Small Water Area Twin Hull) vessel owned by the U.S. Navy and operated by the University of Hawai‘i.

This cruise supplements data from a prior cruise [2] to identify the morphology of the Foot of the Slope (FoS) around the northern end of the Line Islands chain, Figure 1.1. The cruise consisted of primary bathymetric mapping in water depths of approximately 5000 m using the R/V *Kilo Moana* (Figure 1.2), operated by the University of Hawai‘i. The primary mapping sonar was a Kongsberg EM122 multi-beam echosounder (bathymetry and acoustic backscatter), with a Knudsen Engineering 3260 chirp sub-bottom profiler, and a Bell Aerospace BGM-3 marine gravimeter. Motion measurement was provided by an ApplAnix POS/MV 320 GPS-aided inertial motion unit, while sound speed profile measurements were conducted using Sippican expendable bathythermograph (XBT) and expendable conductivity, temperature and depth (XCTD) probes. Details of the systems used can be found in Section 2. Scientific personnel for the cruise were provided by CCOM-JHC, Memorial University, University of Southern Mississippi, NOAA National Center for Environmental Information, and GEOMAR (Helmholtz-Zentrum für Ozeanforschung Kiel), and the marine technician group provided by University of Hawai‘i. The personnel list can be found in Section 6.

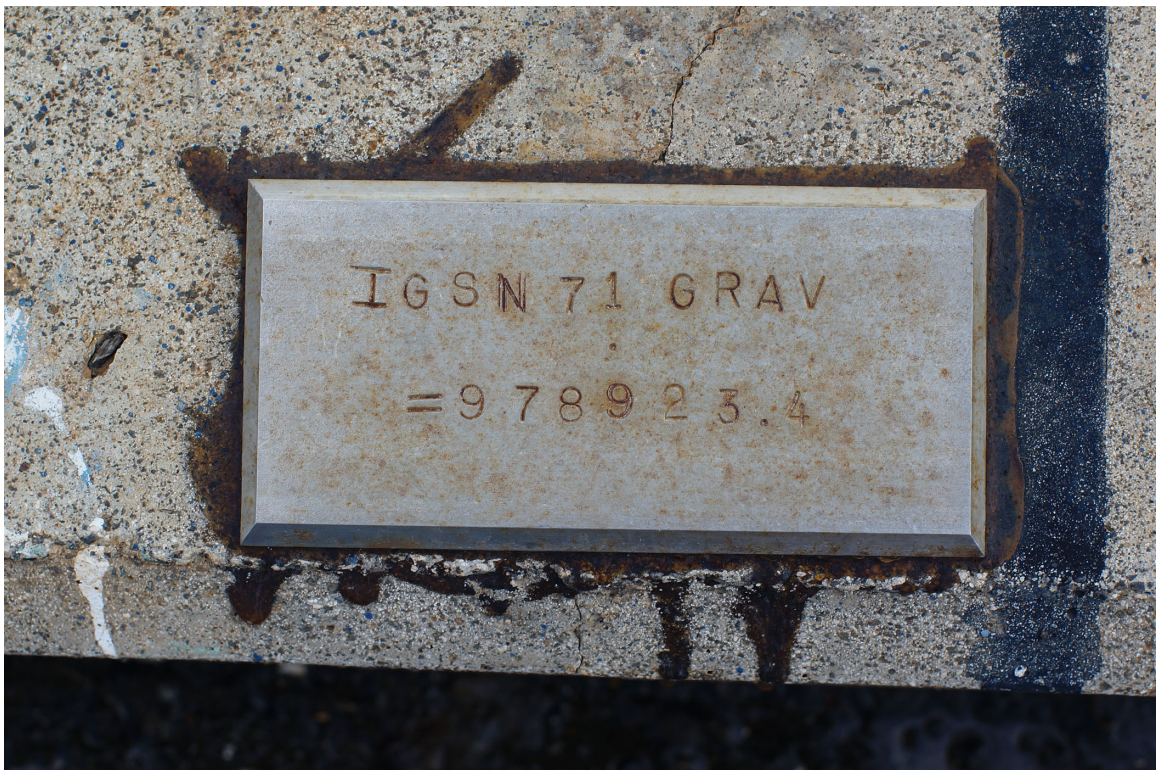
Figure D.7: Gravity station monument plaque corresponding to the station description in Figure D.6.
